Worldwide repairs carried out with PolymerMetall®

REP-#154

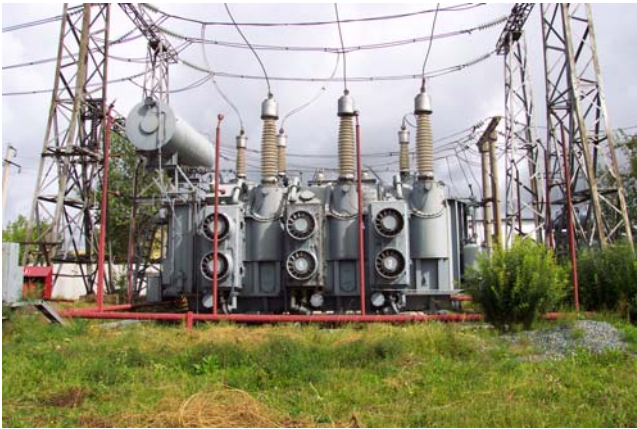
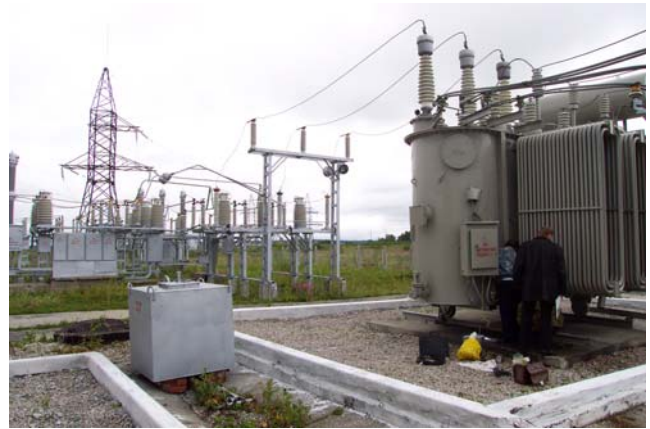
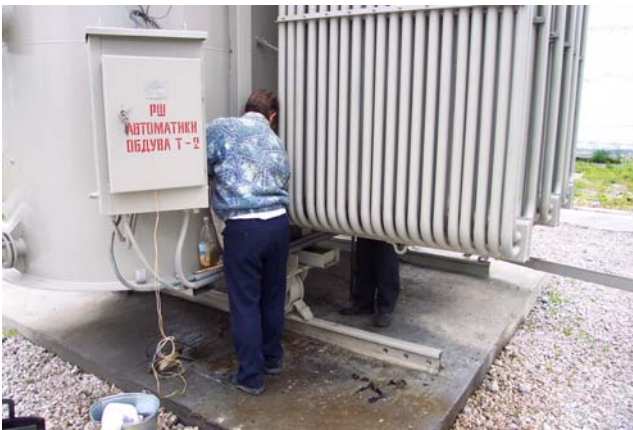
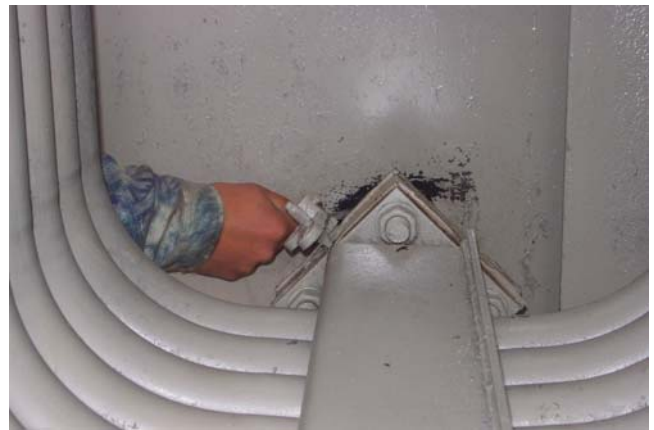
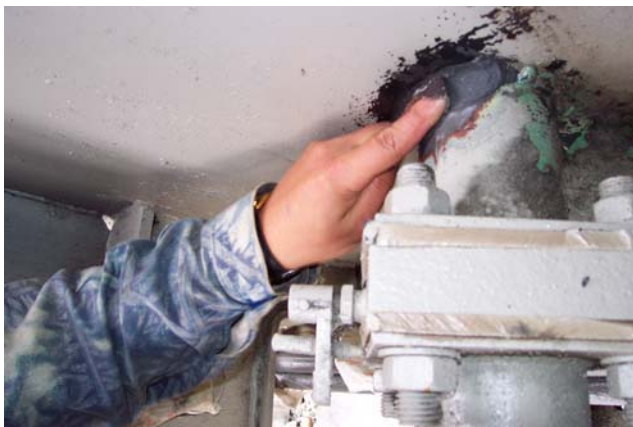
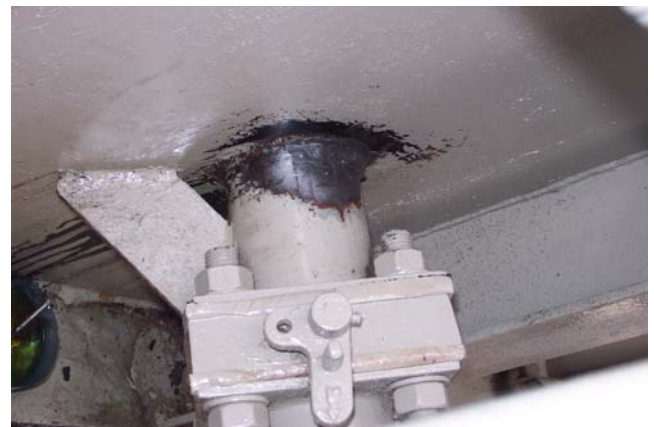
Oil exuded through micro cracks caused by vibration in a defective welded seam. The leak of oil has amplified after unsuccessful attempt to execute repair by usual welding. Then it was decided to carry out a repair by using the "Direct-MM-Bonding"- technology with the help of MM-metal oL-steelceramic and hardener red followed by a second layer of MM-metal oL-steelceramic with hardener yellow.
